THORVALDSENS MUSEUM

NEW COURTYARD PAVEMENT

BY PER JACOBSEN, DEPARTMENT OF CONSULTING ENGINEERS OF THE CITY OF COPENHAGEN

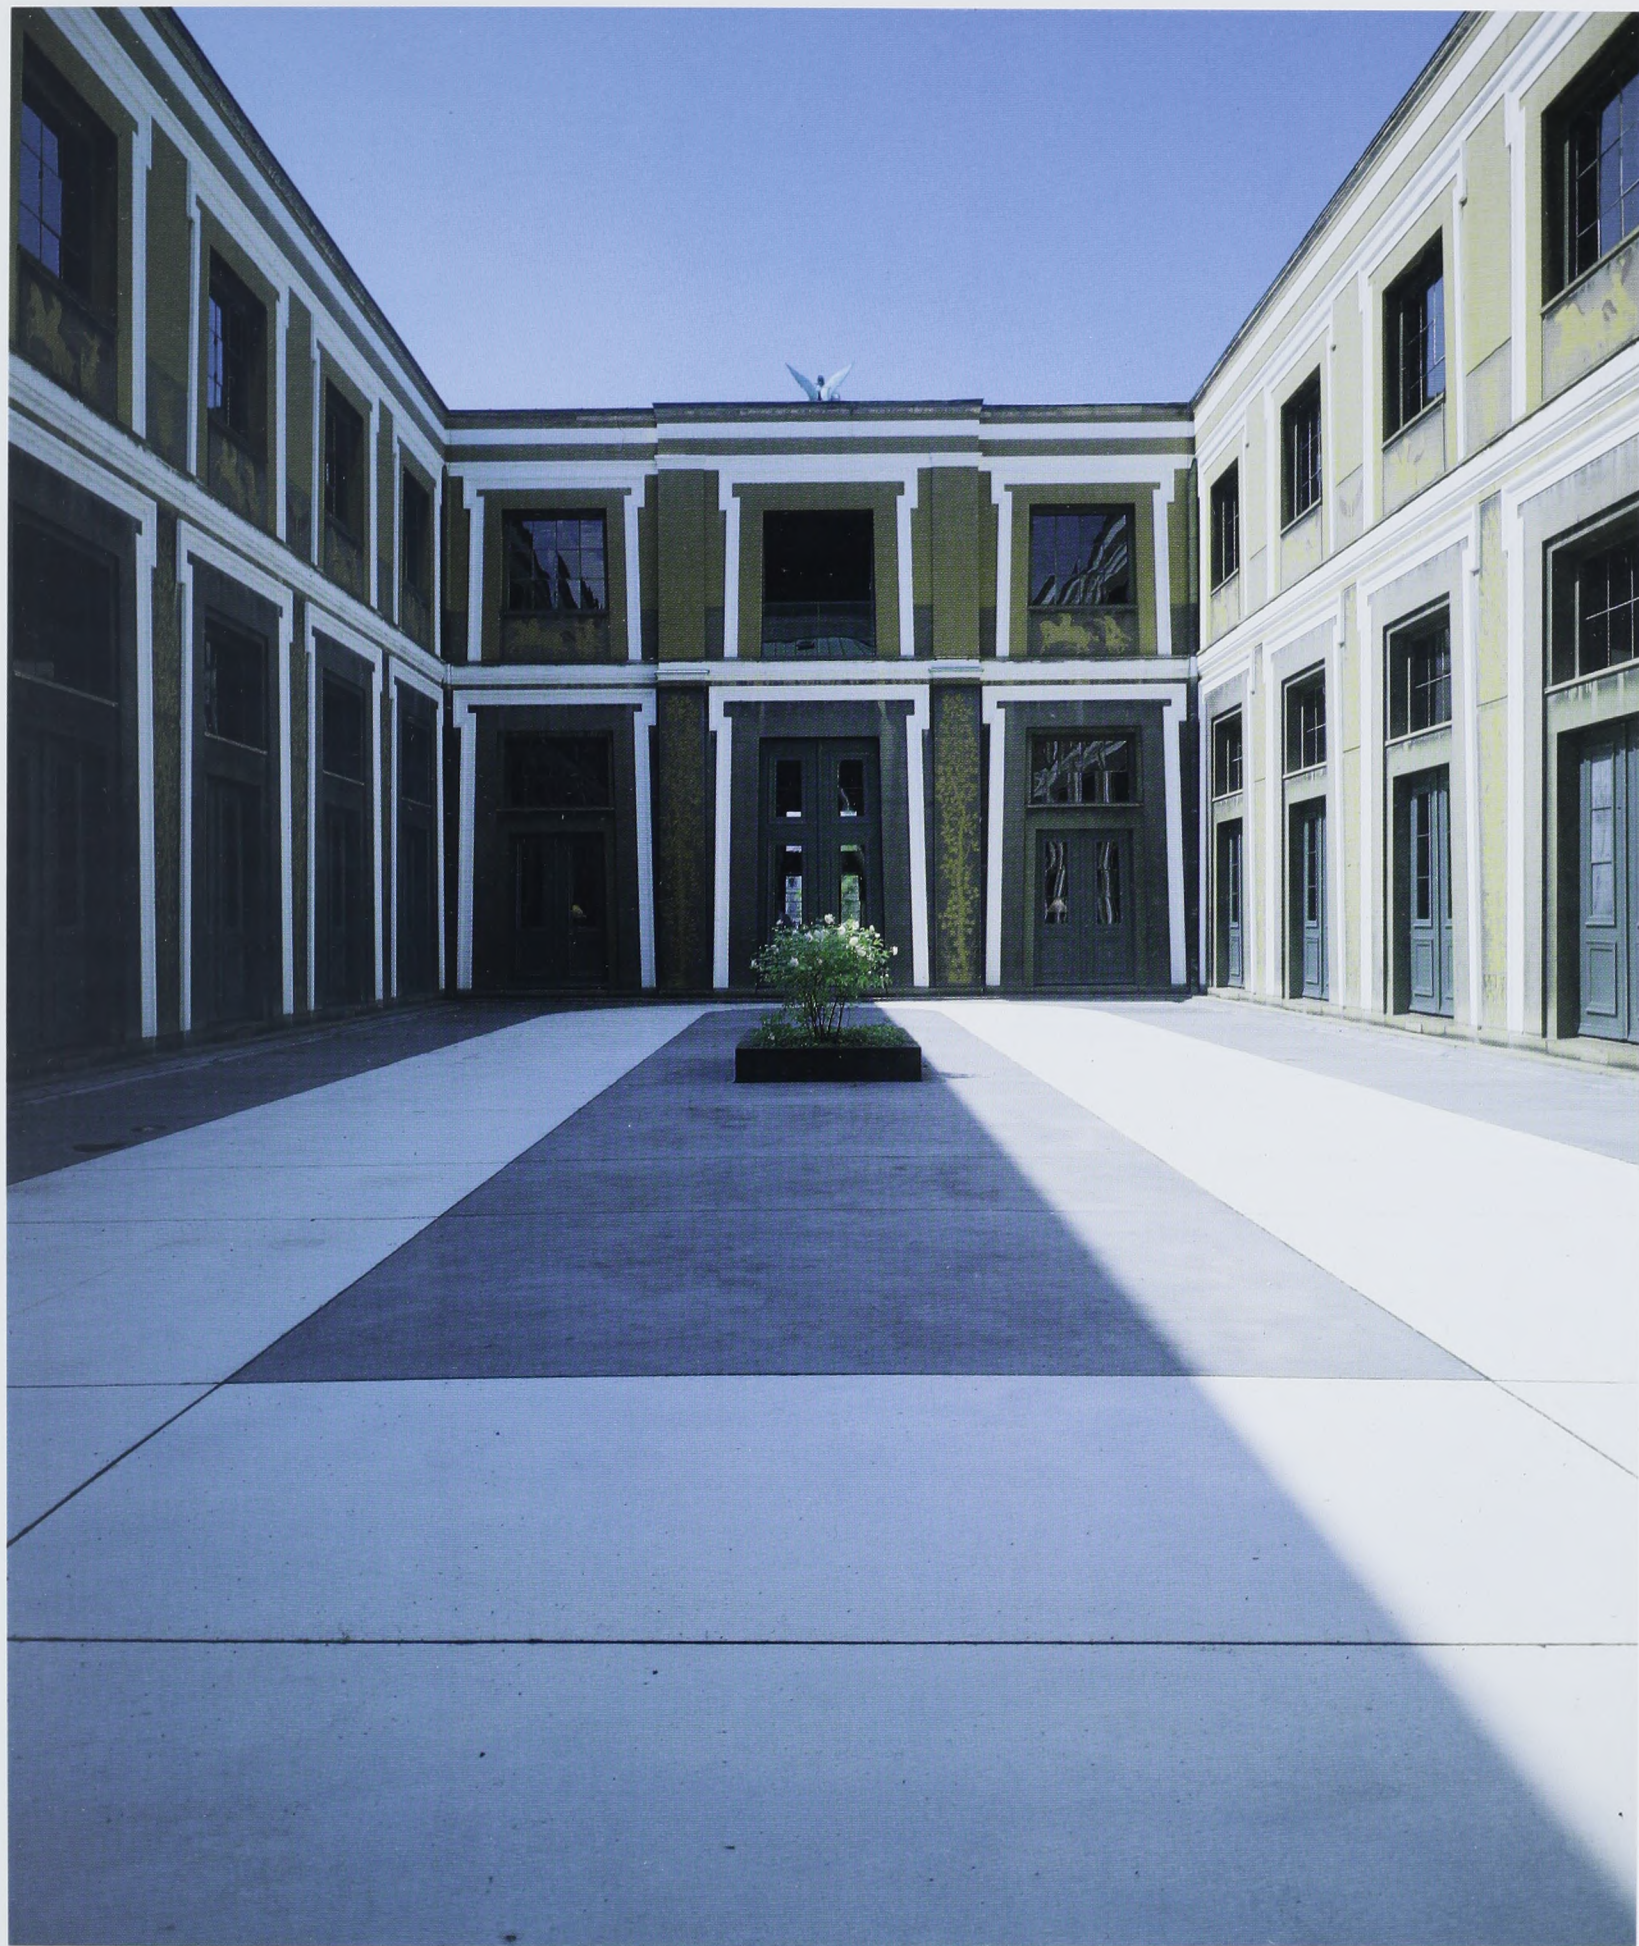
FIG. 109. The courtyard of Thorvaldsens Museum after the renovation 1995.

It was decided to carry out a complete reconstruction of the entire pavement; the deteriorating concrete was removed and a new base course consist-

After the placing of the pre-cast concrete flagstones gutter and boundary, the gravel base was covered with a geotextile and the concrete was cast with a slab thickness of 10 to 12 cm. The slabs were cast in one layer without reinforcement. Two types of concrete were used to obtain the original colours: The white concrete was composed using white cement, 0/2 mm and 6/9 mm crushed Carrarra marble aggregates. For the dark concrete an ordinary Portland cement was used in combination with a carbon black colouring agent, quartz sand 0/2 mm and crushed labradorite aggregates from Tjølling in Norway.

After hardening the surface of the concrete was ground and polished applying the terrazzo technique which was also used for the original pavement. The construction and contraction joints were cut into equal widths and filled with a bottomstop and argillaceous unigrained gravel.

The drainage system has been renewed, using the original bronze cast outlet gratings. The geometry of the pavement is now in accordance with Kaare Klint's original intentions, which has resulted in an improved drainage. As a consequence, the centre of the pavement in the atrium has been elevated by 9 cm and the level of the flower bed over the grave has been raised correspondingly.
